Manhole Inspection Summary

Manhole # S45G__016MH

Insp Date: **3/12/09 11:05 AM**

Location Address: **203 s washington st**

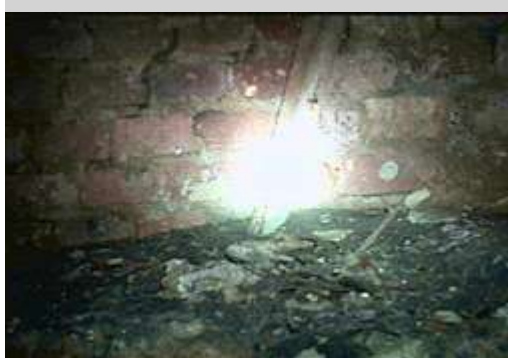
Defect 3

Condition: ☐ Sound ☐ Cracked ☐ Root Intrusion ☐ Deteriorated ☐ Leaks ☒ **Debris**

bench debris

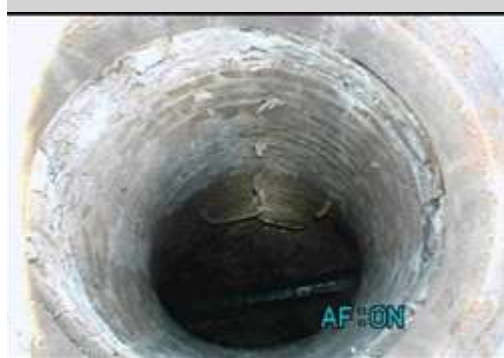
Defect 2

Steps Count: **6** Missing: **3** ☒ **Corroded**

missing/corroded steps

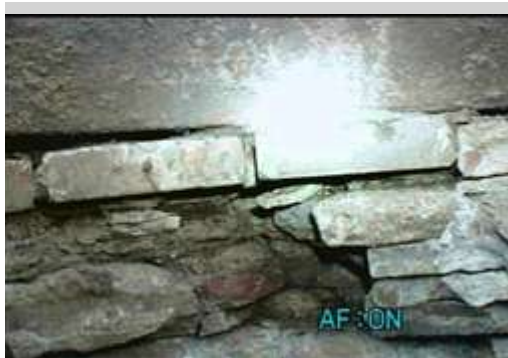
Defect 1

Chimney / Frame Adjustment ☒ Exists Material: **Brick and Concrete** ☐ Parged Height: **8** (in.)

Condition: ☐ Sound ☒ **Cracked** ☐ Root Intrusion ☒ **Loose Brick** ☒ **Deteriorated**

chimney cracked, deteriorated with loose brick
